BASF Wyandotte

From Robert L. Jelacic

31st Street Landfill - Huntington

IW-5959-7.9

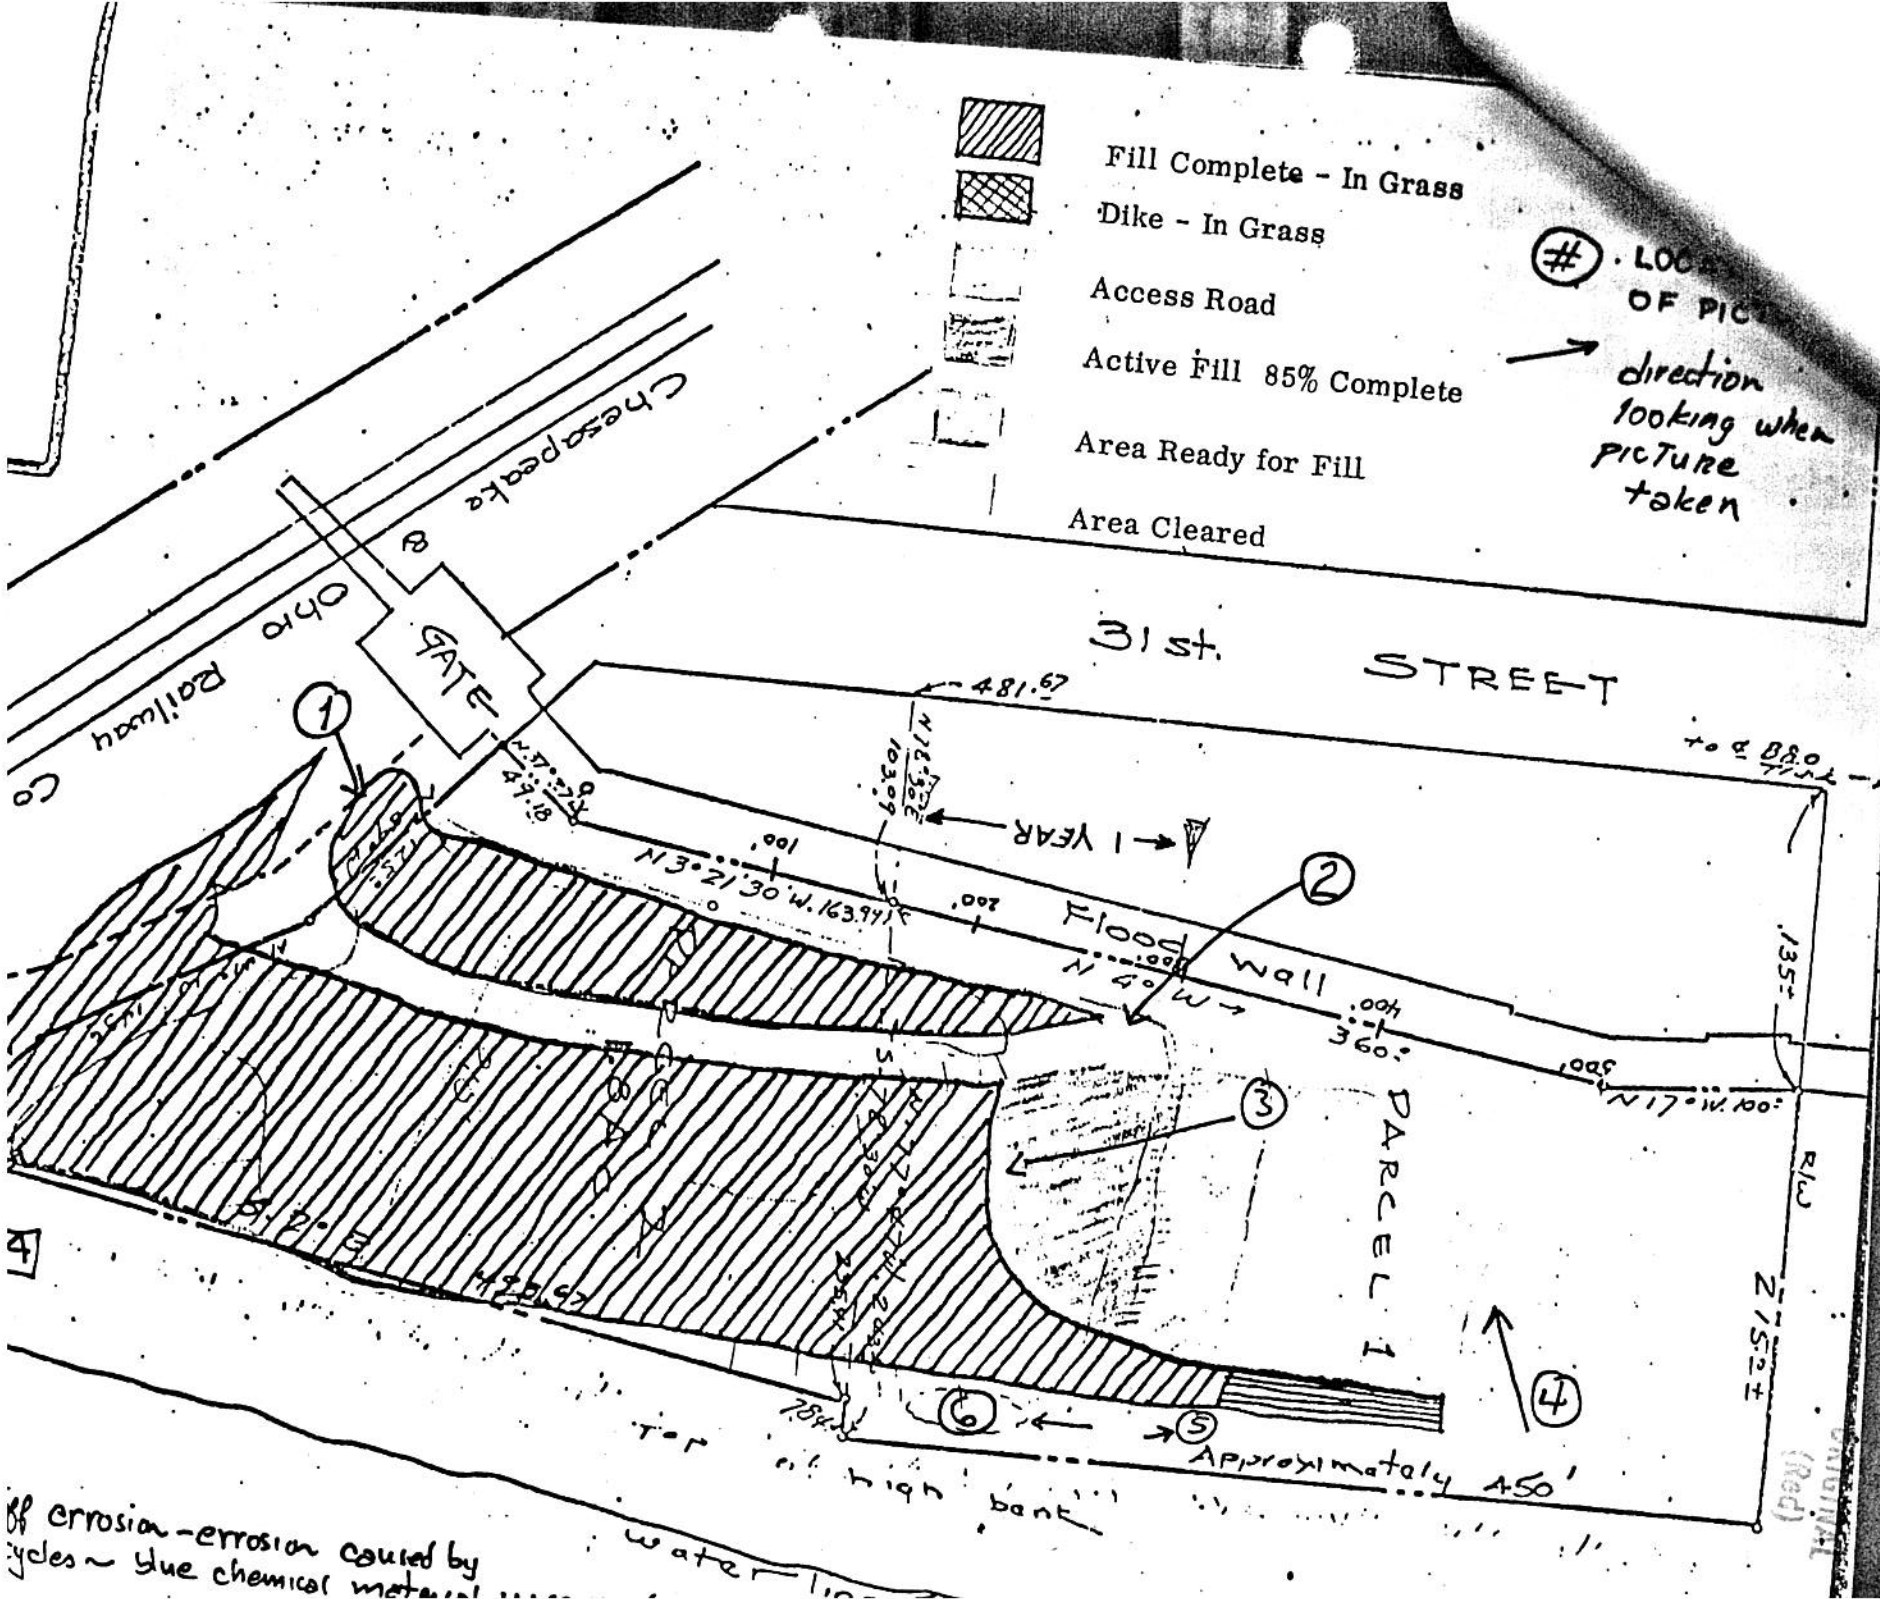
LOC OF PICT

There was evidence of runoff from the site both on the completed fill section and the "active" fill section. Evidence of runoff on the north end shows where ponding occurred and where the water entered the river.

erosion - erosion caused by
cycles - blue chemical material

Access to the area is not controlled and entry onto the site is easily made by going around the Flood wall at the south end of the site. This is a problem because the site is now being used by dirt bikers who are causing erosion problems on the covered and grassed slopes.

There is evidence on the site that sacks of a blue pigment or dye type material was ~~disposed~~ ^{by} disposed of at the site. These sacks were seen in the uncovered section and in the older section where erosion caused by cyclist have exposed one of the bags. Also in some areas of the covered section it appears that a sandy material was used which is now discolored blue possibly from the material leeching upwards through the (material).
TO THE FILL
